REPORT OF FATAL COAL OUTBURST (BUMP) ACCIDENT  
KENILWORTH MINE  
THE NORTH AMERICAN COAL CORPORATION, UTAH DIVISION  
KENILWORTH, CARBON COUNTY, UTAH

April 14, 1970

William Bazo  
Federal Coal Mine Inspector

E. J. Grillos  
Mining Engineer

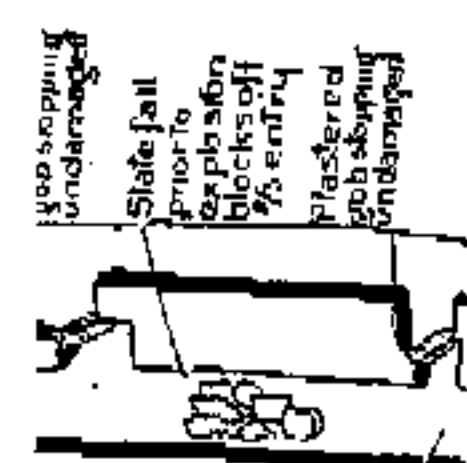
Figure 142.—Sketch of explosion area, Kenilworth mine, Kenilworth, Utah, March 14, 1945.

At 1:15 p. m. 16 men were working in No. 5 panel on the 3d east entry off No. 2 slope, when a severe bounce occurred in the pillar that was being mined next to the caved area. Although all of the electrical equipment in the panel was idle, the flying coal pulled the trailing cable of a loading machine with such force that it was severed and short-circuited on the edge of the pipe conduit entering the machine. An arc was formed that ignited the coal dust and methane in the air as a result of the bounce. Flame filled most of the area and burned 12 of the men severely. A shot firer just outside the flame was knocked down but not injured, and three timbermen also beyond the flame were not affected. The shot firer cut off power from the section and telephoned to the dispatcher for assistance. The injured men were given first aid and removed to the hospital. All men were sent out from other sections. Later seven of the injured died.

vivors stated that the flame lasted 10 seconds or longer. The well-rock-dusted condition of the mine confined the explosion to the immediate area (fig. 142). As a precaution a method was devised later for grounding cables and fog nozzles were used to allay dust. Water saturation of pillars was also adopted.
